# Rad-X Medical Power Filtration System<sup>®</sup> (Rad-X Filter) Catastrophic Voltage Event Case Study

<b>Site Name</b>	McLaren Imaging Center
<b>Location:</b>	Flint, Michigan
<b>Protected Equipment:</b>	Philips Diamond Select 64 Slice CT
<b>CT Manufacturer Supplied Protection:</b>	TVSS mandated by the CT manufacturer
<b>McLaren Health Supplied Protection:</b>	Rad-X Filter

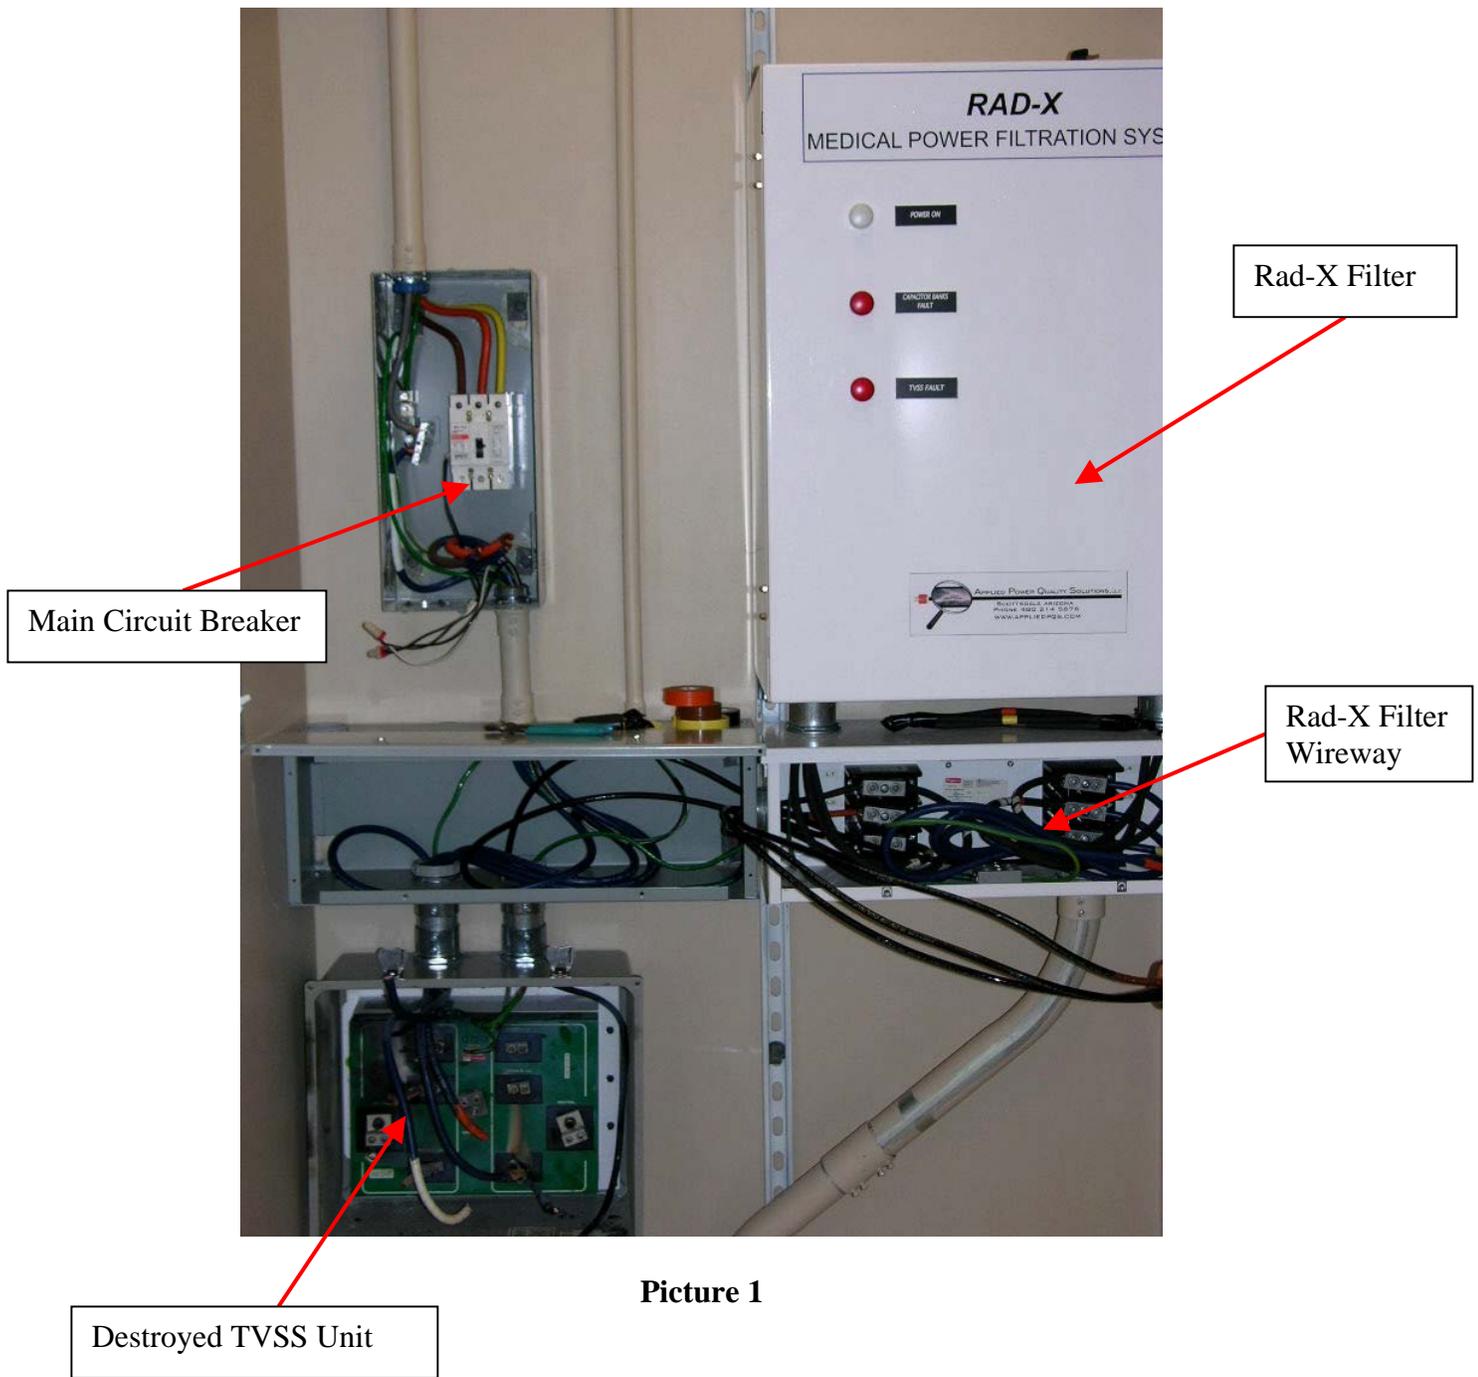
On Wednesday March 31, 2009 what appears to have been a major voltage event hit the Imaging Center's electrical system. The Philips supplied TVSS unit was completely destroyed (**pages 2 & 3**). The Rad-X Filter which was installed between the TVSS unit and the CT was undisturbed by the event. Most importantly, the CT itself did not sustain any damage as a result of the event.

**Picture 1** illustrates the destroyed TVSS unit and the Rad-X Filter which was unaffected by the voltage anomaly.

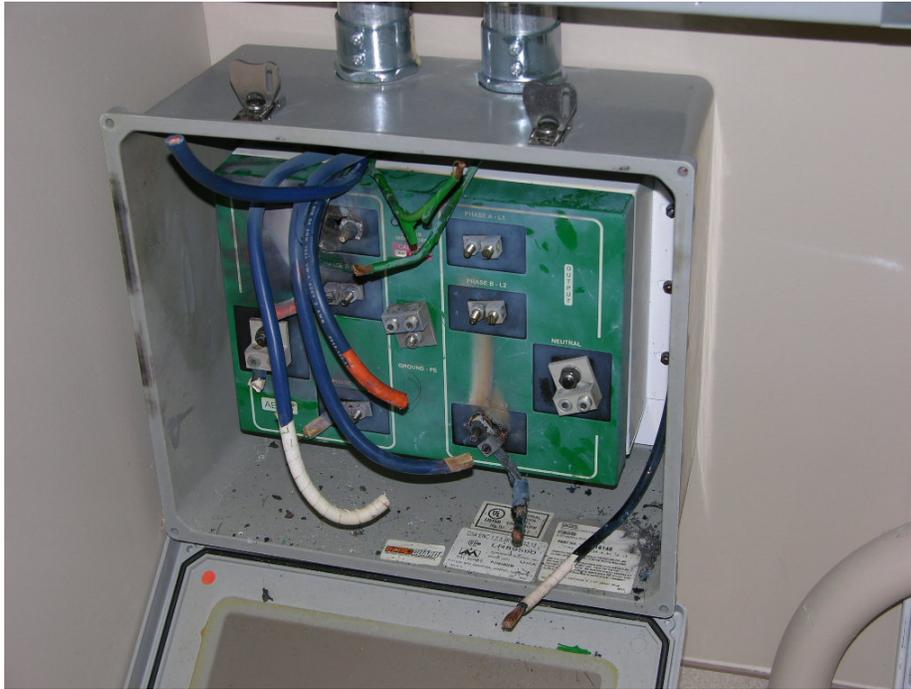
**Picture 2** illustrates the complete destruction of the TVSS unit. All phase, neutral and ground conductors were blown off of their connectors.

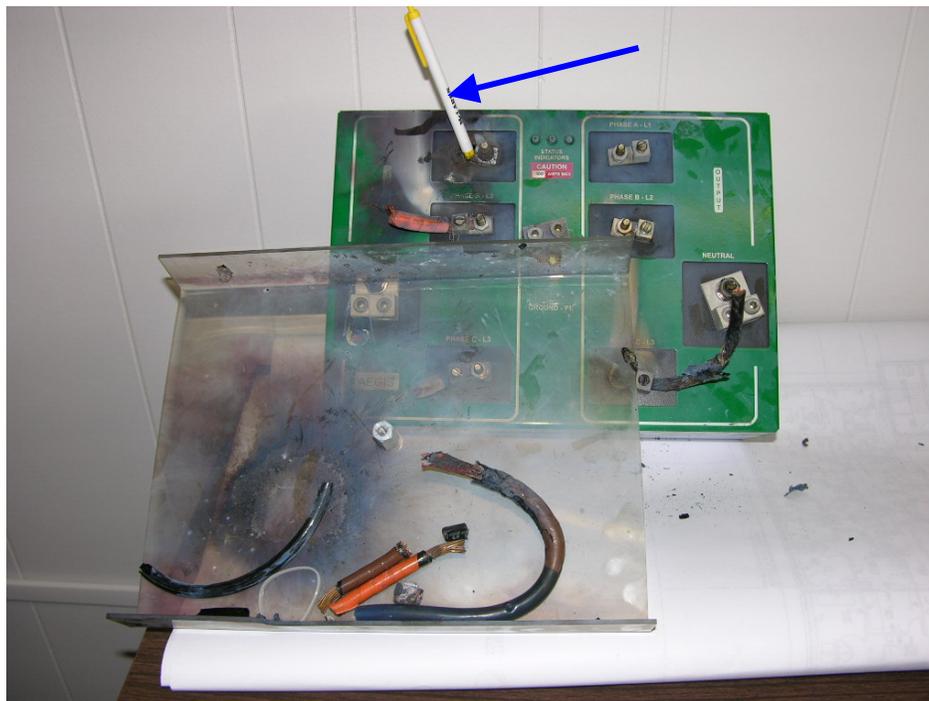
The blue arrow in **Picture 3** illustrates a pen size hole blown through the front of the TVSS unit. We can see several of the burned conductors lying on the clear plastic faceplate.
